Navajo Abandoned Uranium Mine Site Screen Report

Silver Bit No. 18 AUM Site

Navajo AUM Eastern Region

May 2009

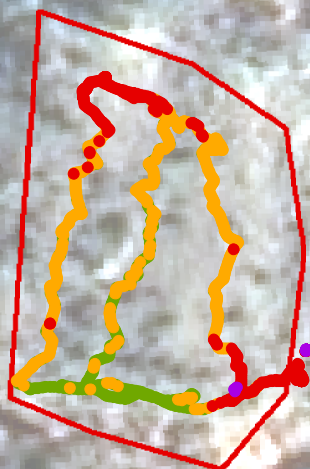
Figure 2

A total of 1,349 gamma radiation measurements were collected from the mine site, ranging from 10,636 cpm to 54,684 cpm. The measurements are represented in Figures 1 and 2. Radiological measurements collected for the New Mexico Mining and Minerals Division during a 2008 field screening survey found gamma radiation levels near the ground surface with a maximum of 160 micro Roentgen per hour ($\mu\text{R/hr}$) and a minimum of 24 $\mu\text{R/hr}$, levels at the 4-foot elevation with a maximum of 160 $\mu\text{R/hr}$ and a minimum of 21 $\mu\text{R/hr}$, and background levels of less than 20 $\mu\text{R/hr}$.

Gamma survey conducted in October 2008
measured as counts per minute

Gamma Radiation Measurements
Silver Bit No. 18
Baca/Haystack Chapter
Navajo Nation, New Mexico
